# 2004 PROJECT CHANNEL REPORT

INSPECTION OF FLOOD CONTROL PROJECT CHANNELS ON THE SACRAMENTO AND SAN JOAQUIN RIVERS AND THEIR TRIBUTARIES AND THE TRUCKEE RIVER

Prepared By The Flood Operations Branch Flood Project Inspection Section

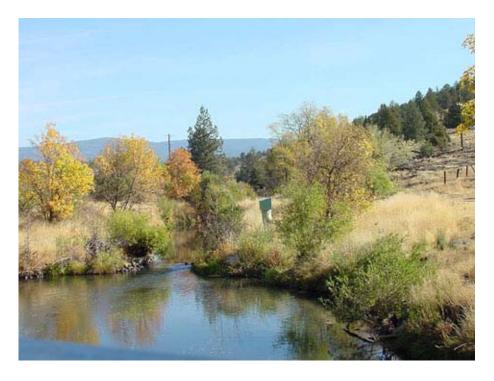
Upstream from Main street (Highway 299) towards the gauging station.

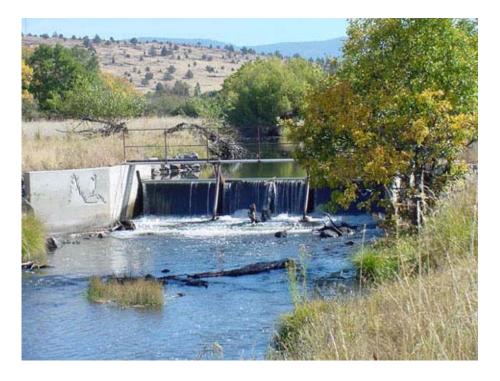
Downstream from the fish ladder and metal walkway.

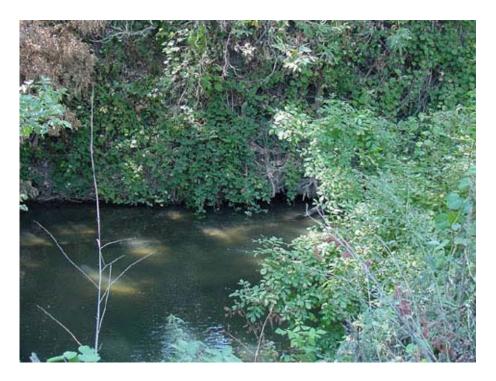
Downstream from the end of Patterson Avenue. Bank vegetation is encroaching on the channel.

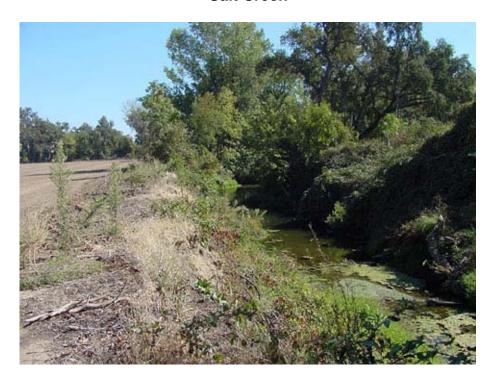
End of Salt Creek road, approximately 200 feet of erosion along left bank.

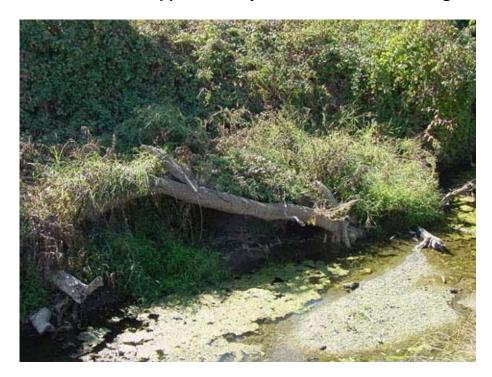
End of Salt Creek road, showing cause of washout and logs in channel.

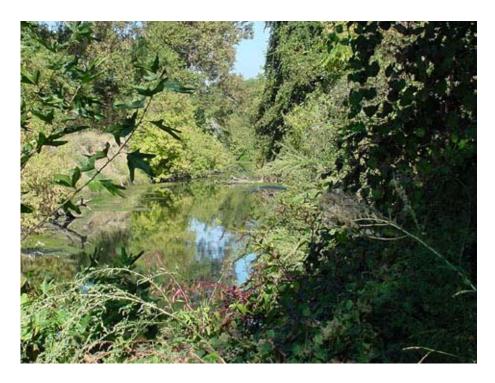
Upstream approximately 200 feet upstream from the confluence with the Sacramento river.

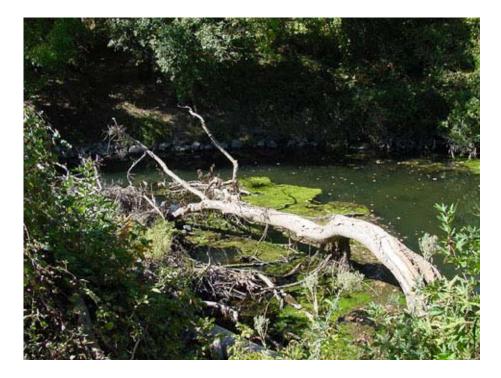
Logs and dense vegetation at the confluence with the Sacramento River.

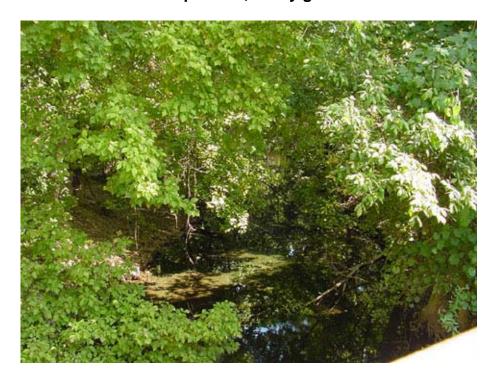
Upstream from Chico State University, heavy growth on both banks.

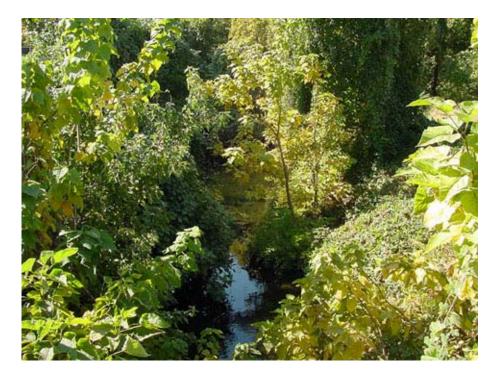
Downstream from Highway 32, heavy growth on both banks.

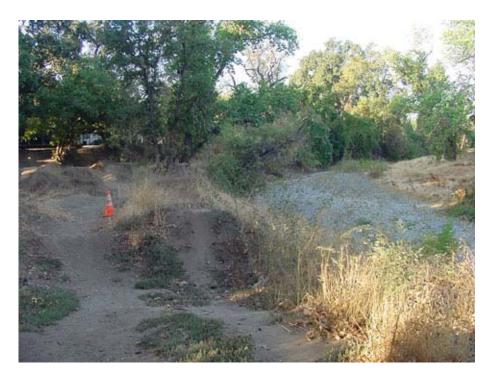
Downstream from Mangrove, the channel and motorcycle damage on left bank.

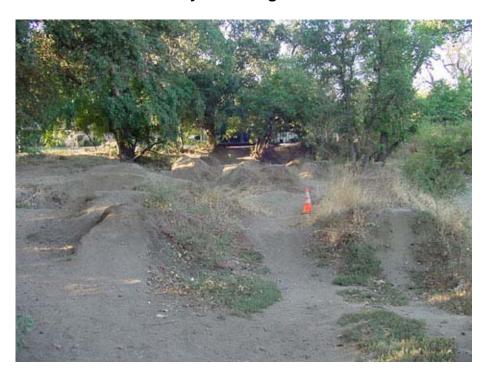
Downstream from Mangrove, motorcycle damage on left bank.

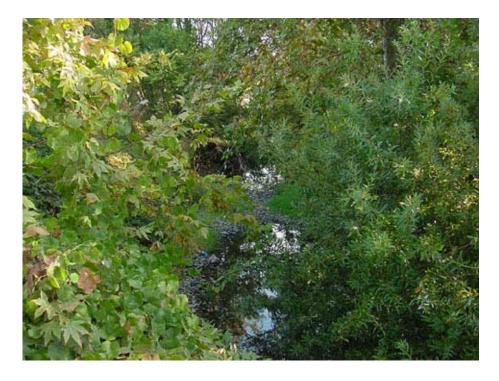
Upstream from Boucher Street. Dense growth on both banks.

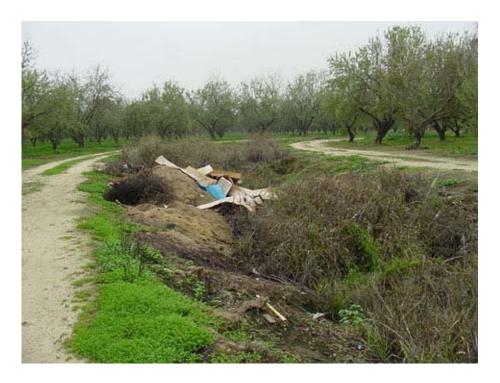
Downstream from Avenue 25, showing garbage in channel.
